11/04/2023

Our Ref: 50097 - Rev 0

**RE: 48 QUAIFFES ROAD, HALSWELL, CHRISTCHURCH
SOIL VALIDATION REPORT**

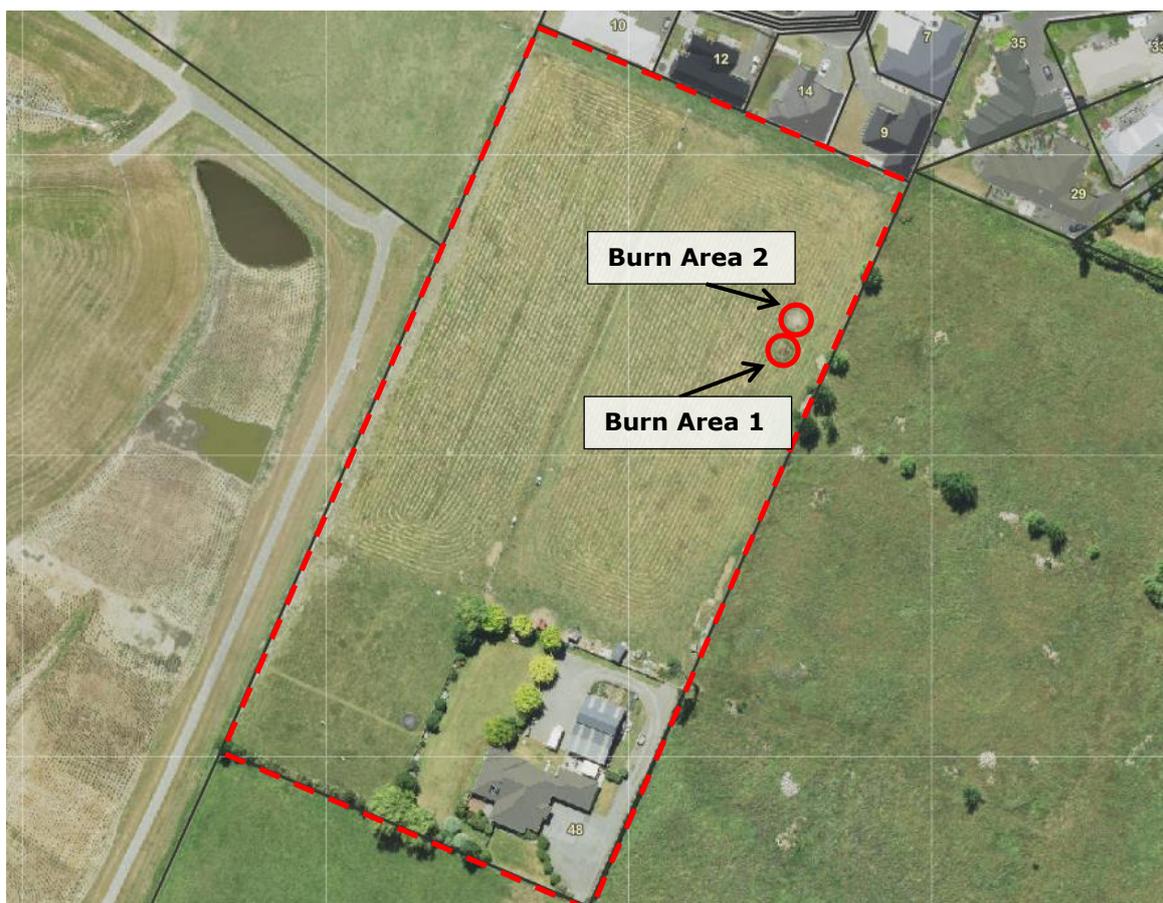
This SVR is limited to overseeing the removal of ash contaminated topsoil and subsequent validation testing of the remaining soil around the two bonfires identified during the site walkover over of the PSI. The location of two burn areas can be found in Figure 1.

Figure 1: Areas of soil removal circled in red, the sites boundary is an outlined in dashed red

The goal of the remediation exercise was to mitigate the risk of contaminated soil contact with the residential end-user by removing the ash contaminated soils from the burnt areas (Figure 1). This was achieved by overseeing the removal of ash contaminated topsoil, validation laboratory testing of the remaining topsoil and confirmation of the disposal of removed soils.

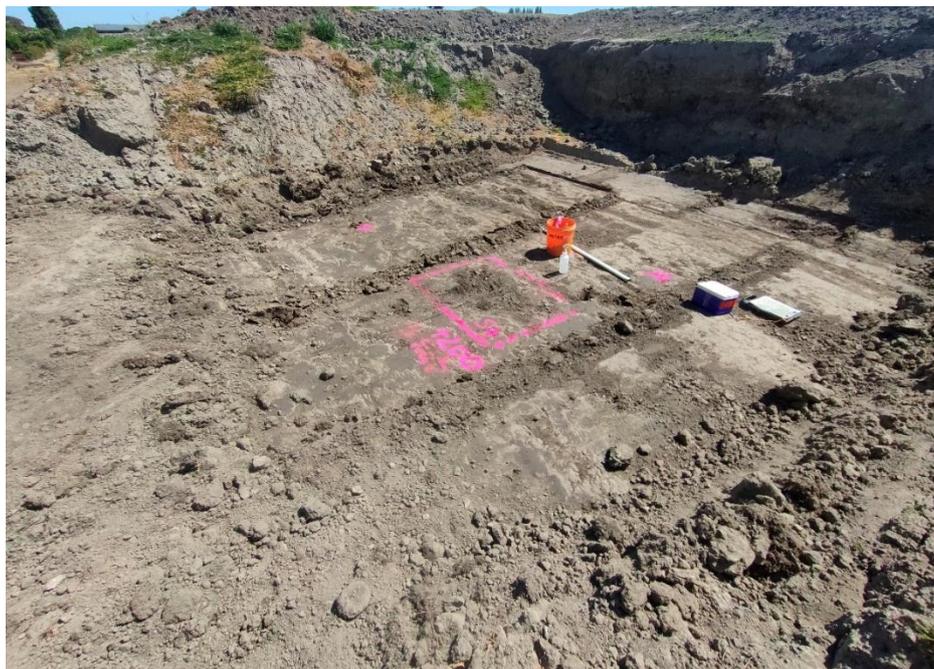
The two burn areas were removed separately and consequently EDC inspected the remediated areas on two dates, 09/11/2022 and 22/02/2023, post the removal of ash-contaminated topsoil. On both occasions the remaining soil (generally topsoil) was free from visual or olfactory indicators of contamination.

A total of approximately 11 tonne of contaminated topsoil, transported by WASTEKO, was sent for disposal at Protranz Earthmoving, Leggett Road on 01 March 2023. Each burn area was approximately 6m x 6m, with ashy material generally contained within the upper 0.2m – 0.3m, with burn area 1 being over-excavated (5m x 3m, and an additional 0.3m deep).

Figure 2: View of Burn Area 1, post stripping of ashy soil. The area marked out in pink has been over-excavated. Photo taken 09/11/2022

Photos of the finished surface and soil which has been over excavated can be found in Figure 2 to 4.

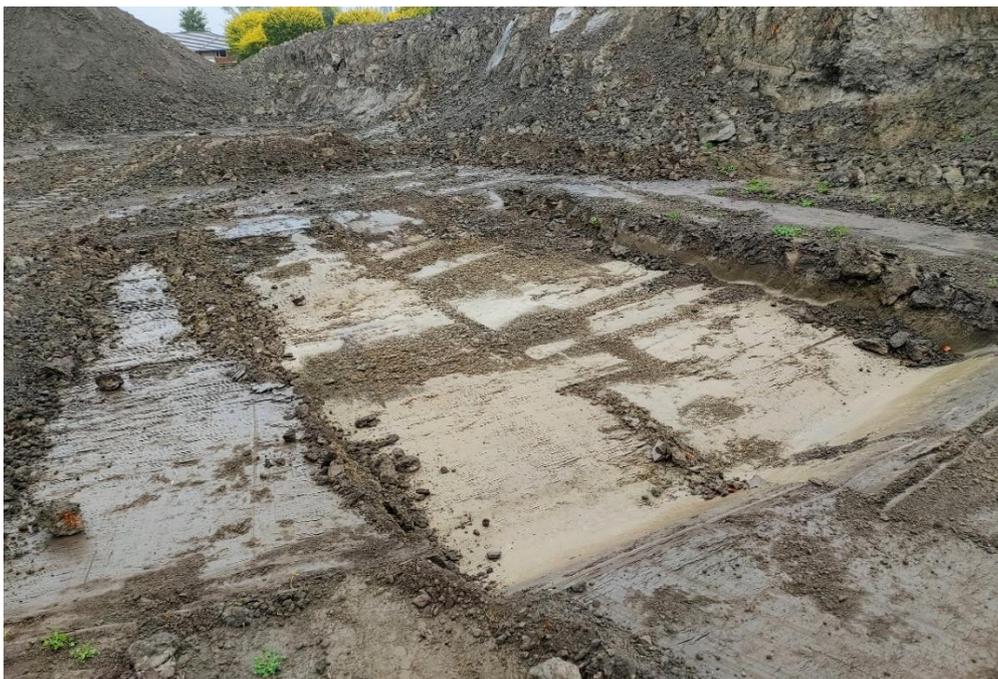
Figure 3: View of Burn Area 1 post over excavation to natural soil, taken 22/02/2023

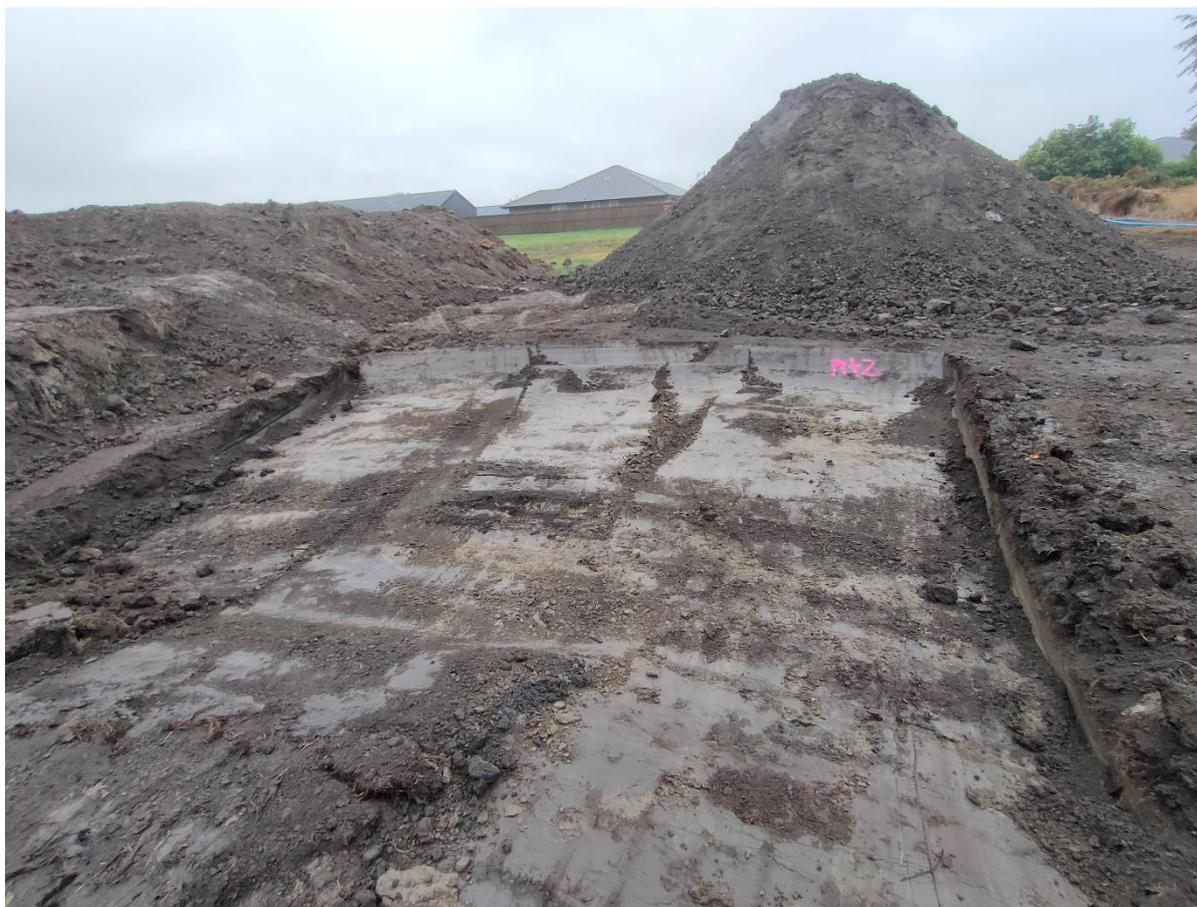
Figure 4: View of Burn Area 2 post stripping of ashy soil, taken 22/02/2023

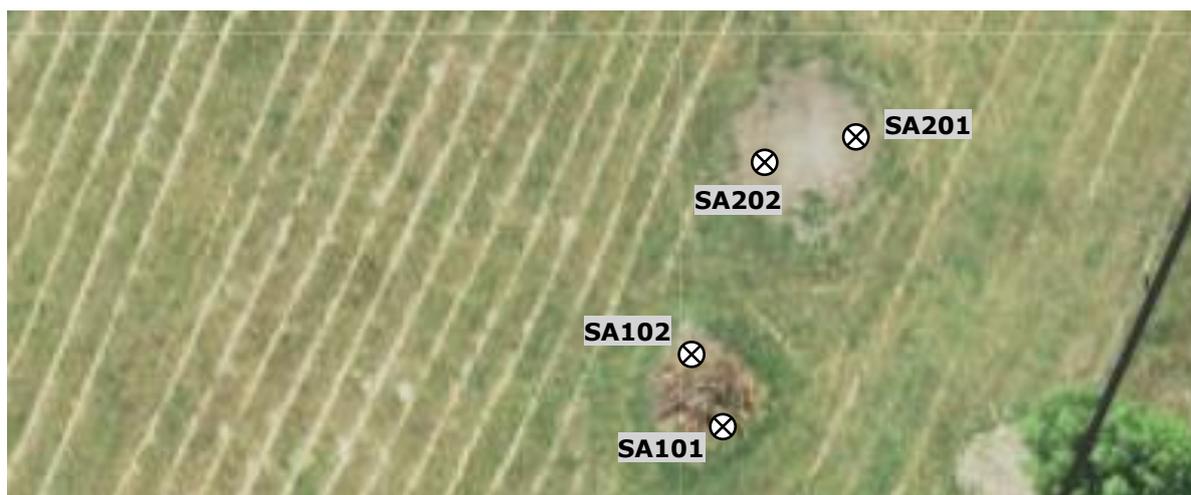
A total of four soil samples, with two from within each burn area, have been used to validate the concentrations of heavy metals and Polycyclic Aromatic Hydrocarbons within the remediated surface (SA101, SA102, SA201 and SA202). This surface was generally 0.2m – 0.3m below the surrounding ground level, with localised areas having been over-excavated an additional 0.3 where any ashy soil in Burn Area 1. The finished level was free from visual or olfactory indicators of contamination. The sample locations are shown on Figure 5.

Two additional samples, one from within the skip (SA103) and one from within the material that has been over-excavated (and SA104) have been analysed for disposal purposes, while these samples are included within the results and chain of custody appendices, they but are not included in the results of this report as they have been disposed of at a suitable facility, as discussed in section 4.

Figure 5: Location of samples

All four samples (SA101, SA102, SA201 and SA202) across the burn areas returned concentrations of elements of concern below that of the Trace 2 background values. All four samples have also been individually been tested for Polycyclic Aromatic Hydrocarbons, which returned results at or below the reporting limit and well below the SCS_(health).

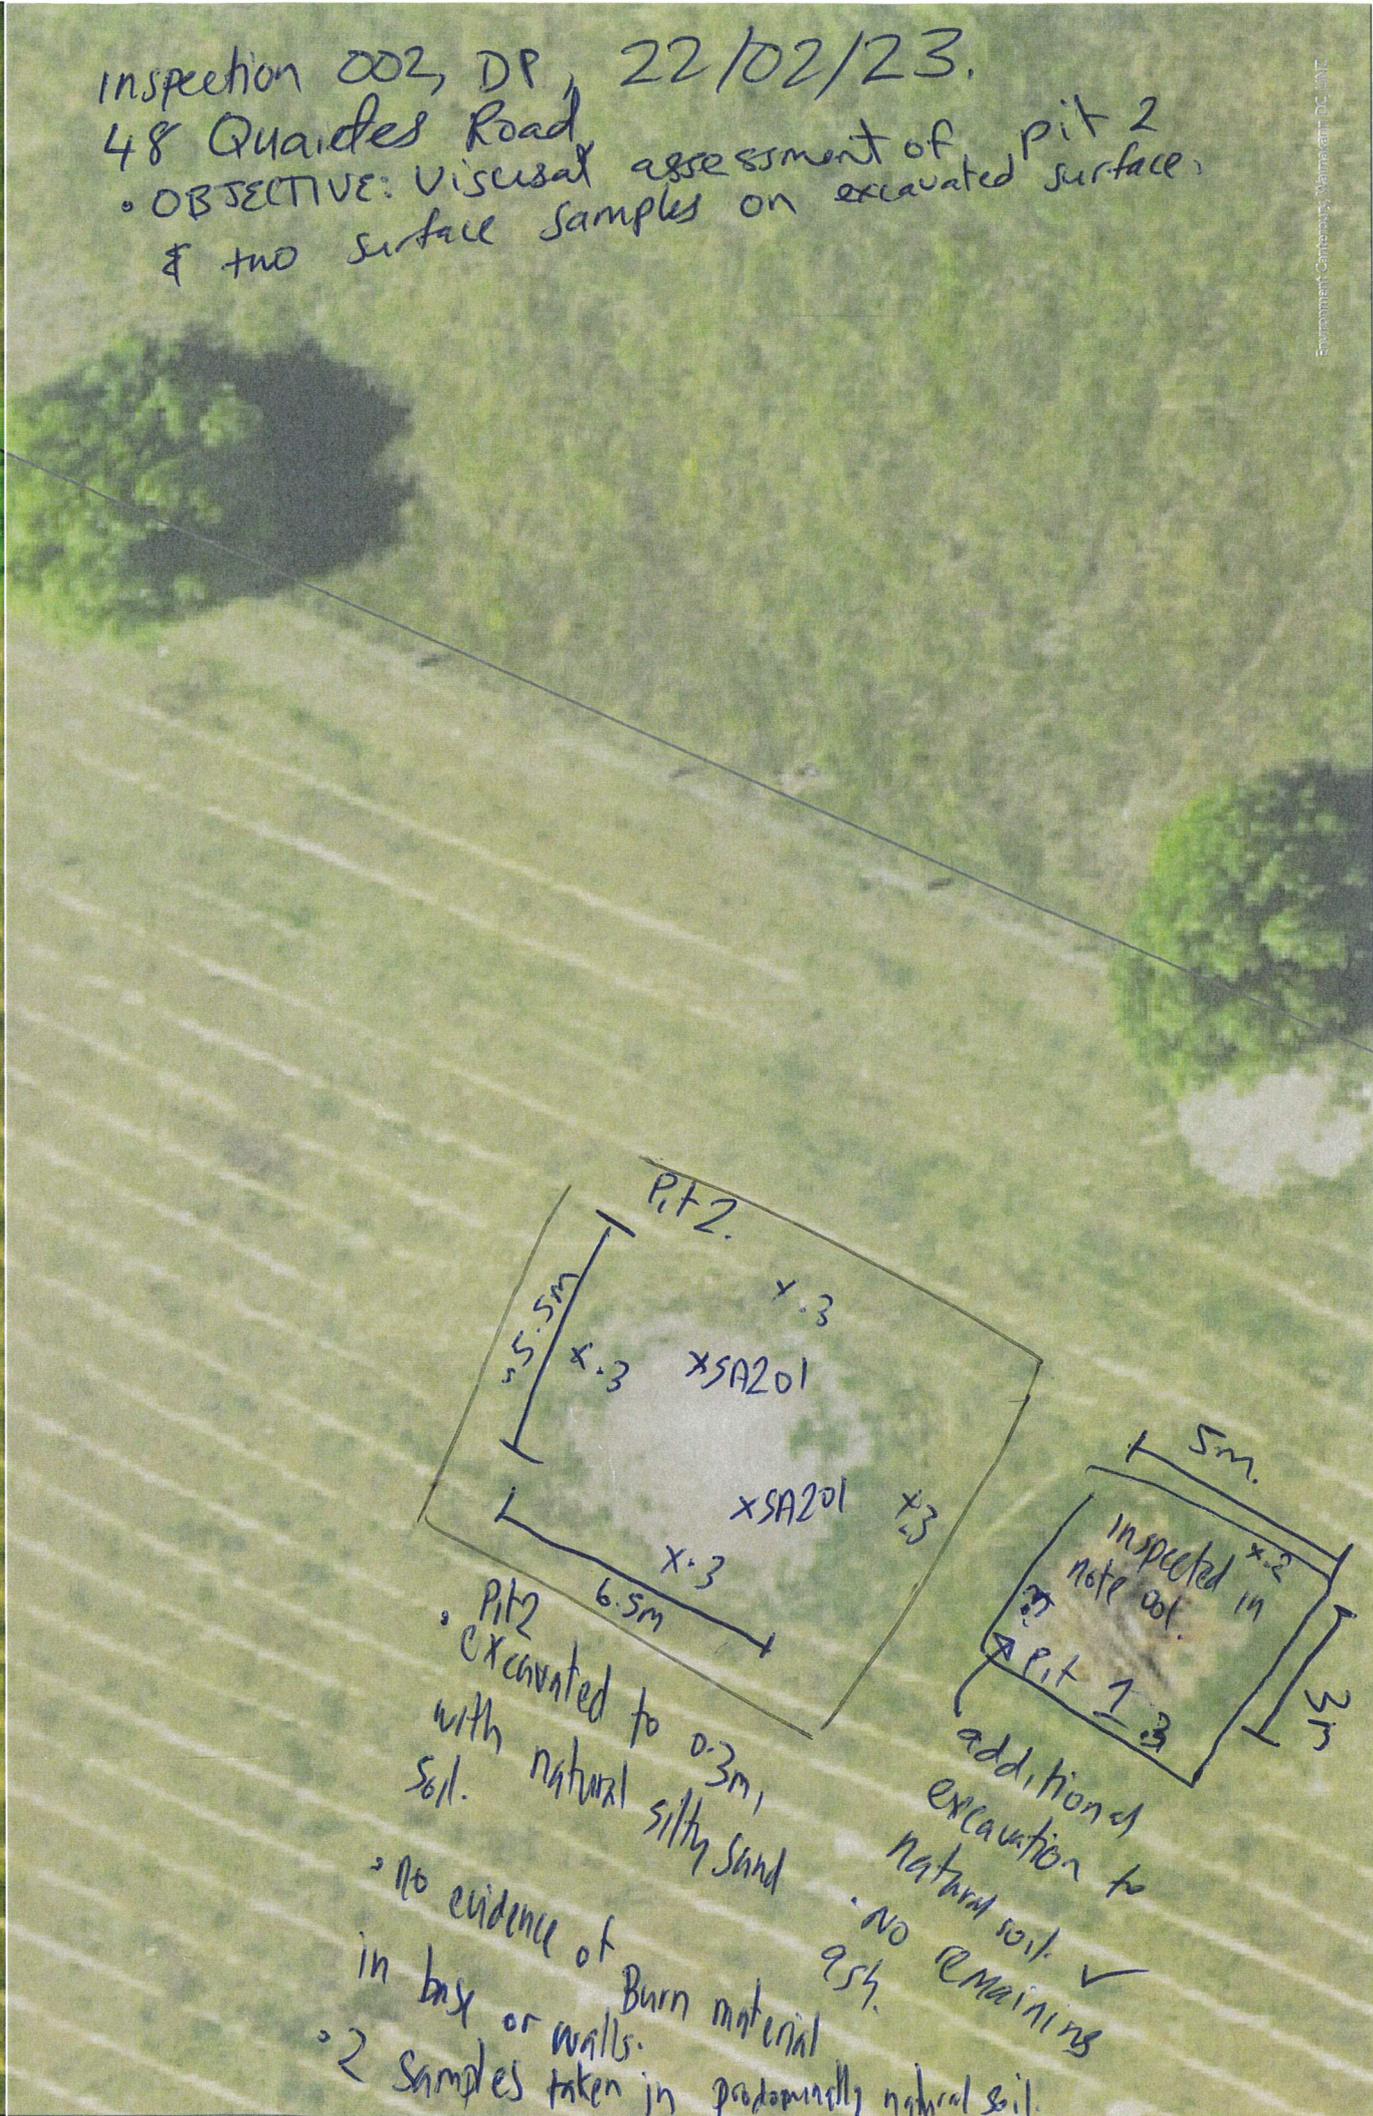
inspection 002, DP, 22/02/23.
 48 Quaides Road
 • OBJECTIVE: Visual assessment of pit 2
 & two surface samples on excavated surface.

- Pit 2 excavated to 0.3m with natural silty sand soil.
- no evidence of Burn material in box or walls.
- 2 samples taken in predominantly natural soil at new surface.
- addition of excavation to natural soil. ✓
- no remains 95%
