# Land Information Memorandum

102A Birkdale Drive

# Geotechnical Investigation Report for Subdivision

Shirley Golf Course, Shirley, Christchurch

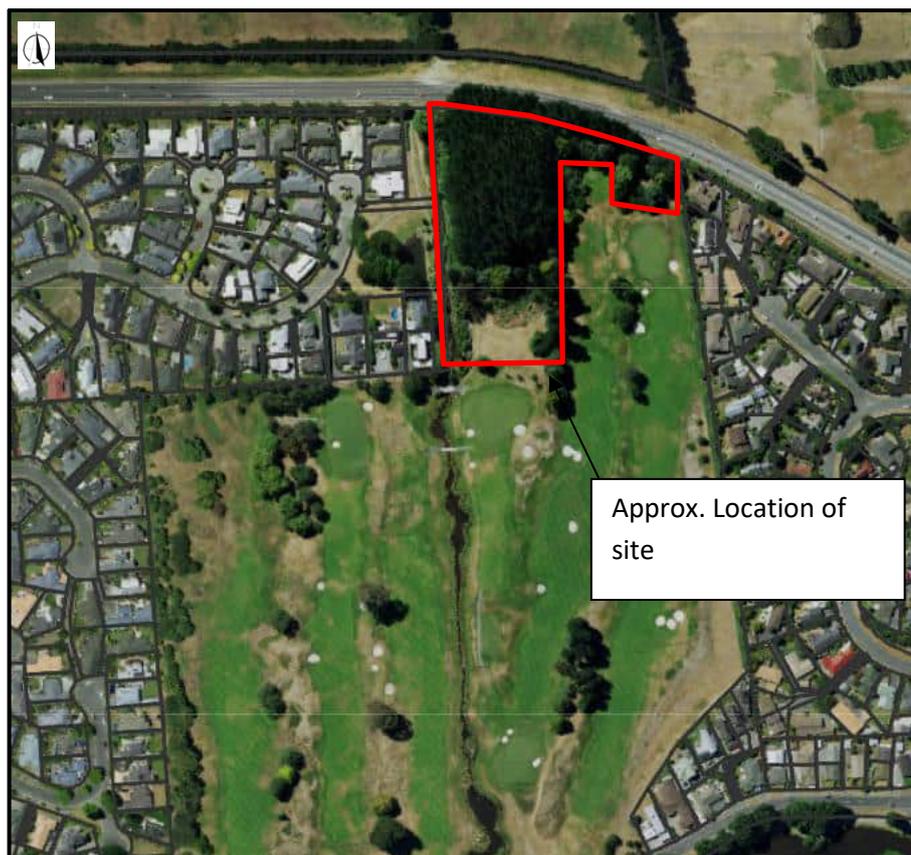
**Figure 1:** Site Location (Taken from Canterbury Maps GIS)

The site is bound to the north by Queen Elizabeth II Drive (State highway 73), to the east and south by areas of golf course and to the west by a small creek, named Old No 2 Drain. The creek/drain is approximately 0.5 m deep and varies between 2.0 m and 5.0 m wide. The site has previously been an area of forestry which had been recently removed at the time of our investigation.

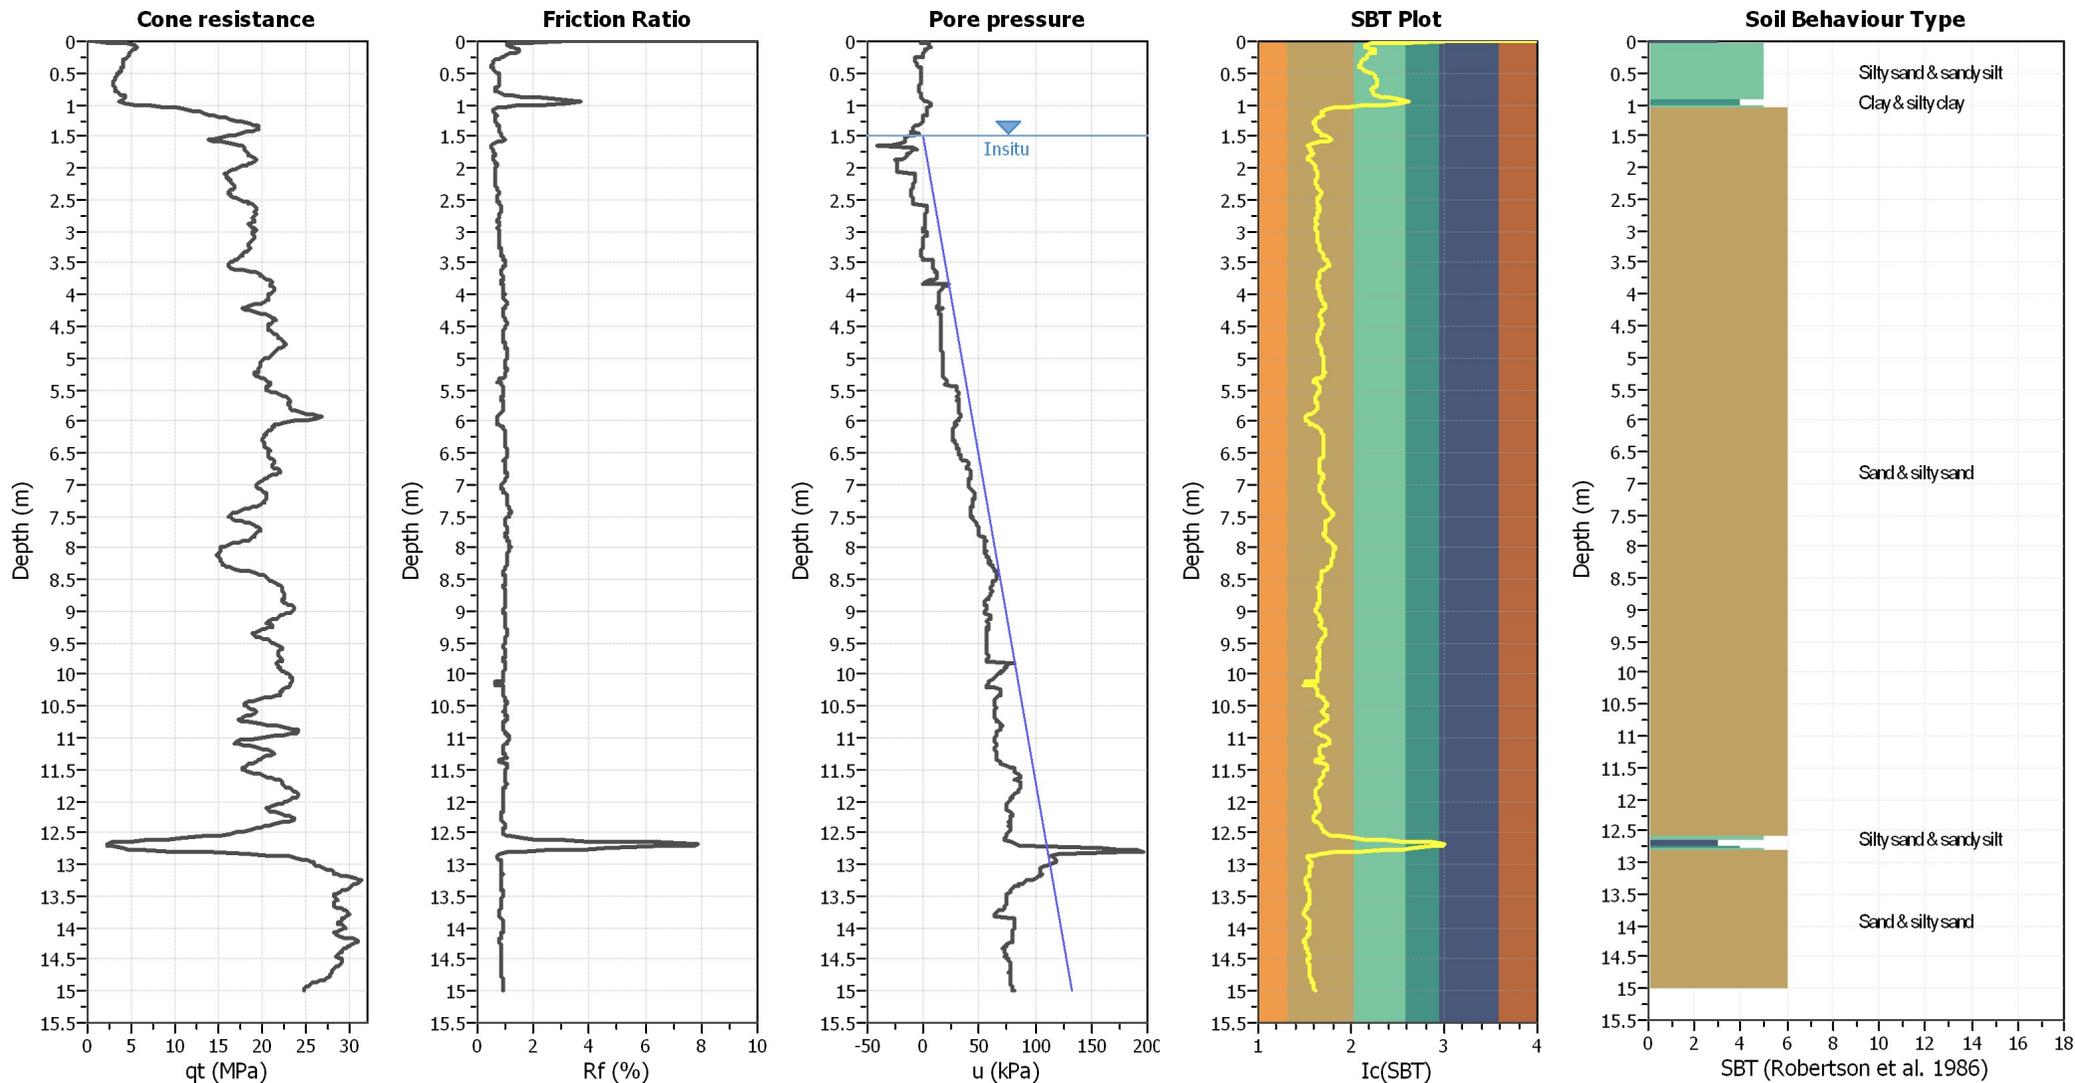
### CPT basic interpretation plots

Analysis method:	I&B (2008)	Depth to GWT (erthq.):	1.00 m	Fill weight:	N/A
Fines correction method:	I&B (2008)	Average results interval:	3	Transition detect. applied:	Sands only
Points to test:	Based on Ic value	Ic cut-off value:	2.60	K <sub>G</sub> applied:	Yes
Earthquake magnitude M <sub>w</sub> :	7.50	Unit weight calculation:	Based on SBT	Clay like behavior applied:	.
Peak ground acceleration:	0.35	Use fill:	No	Limit depth applied:	No
Depth to water table (insitu):	1.50 m	Fill height:	N/A	Limit depth:	N/A

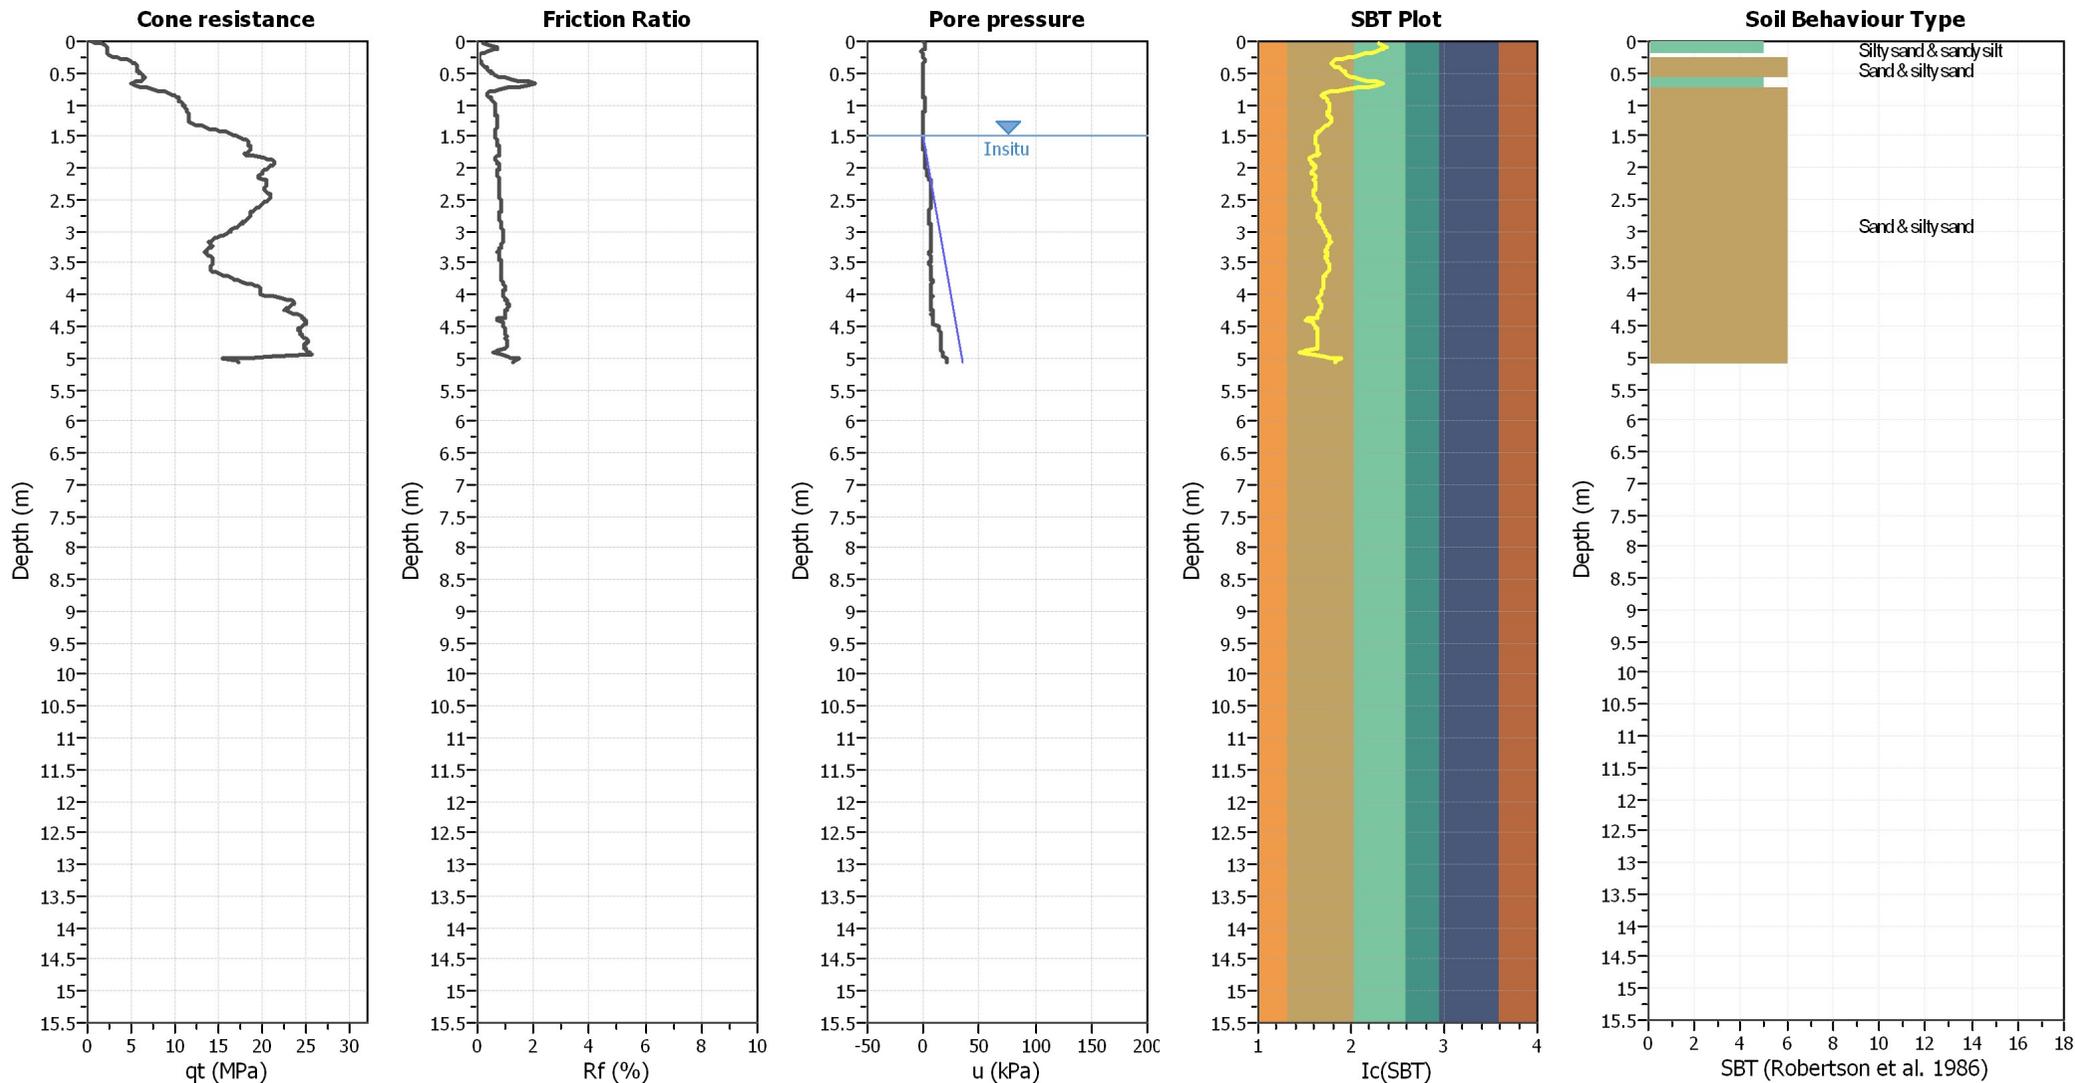
### CPT basic interpretation plots

Analysis method:	I&B (2008)	Depth to GWT (erthq.):	1.00 m	Fill weight:	N/A
Fines correction method:	I&B (2008)	Average results interval:	3	Transition detect. applied:	Sands only
Points to test:	Based on Ic value	Ic cut-off value:	2.60	K <sub>G</sub> applied:	Yes
Earthquake magnitude M <sub>w</sub> :	7.50	Unit weight calculation:	Based on SBT	Clay like behavior applied:	.
Peak ground acceleration:	0.35	Use fill:	No	Limit depth applied:	No
Depth to water table (insitu):	1.50 m	Fill height:	N/A	Limit depth:	N/A

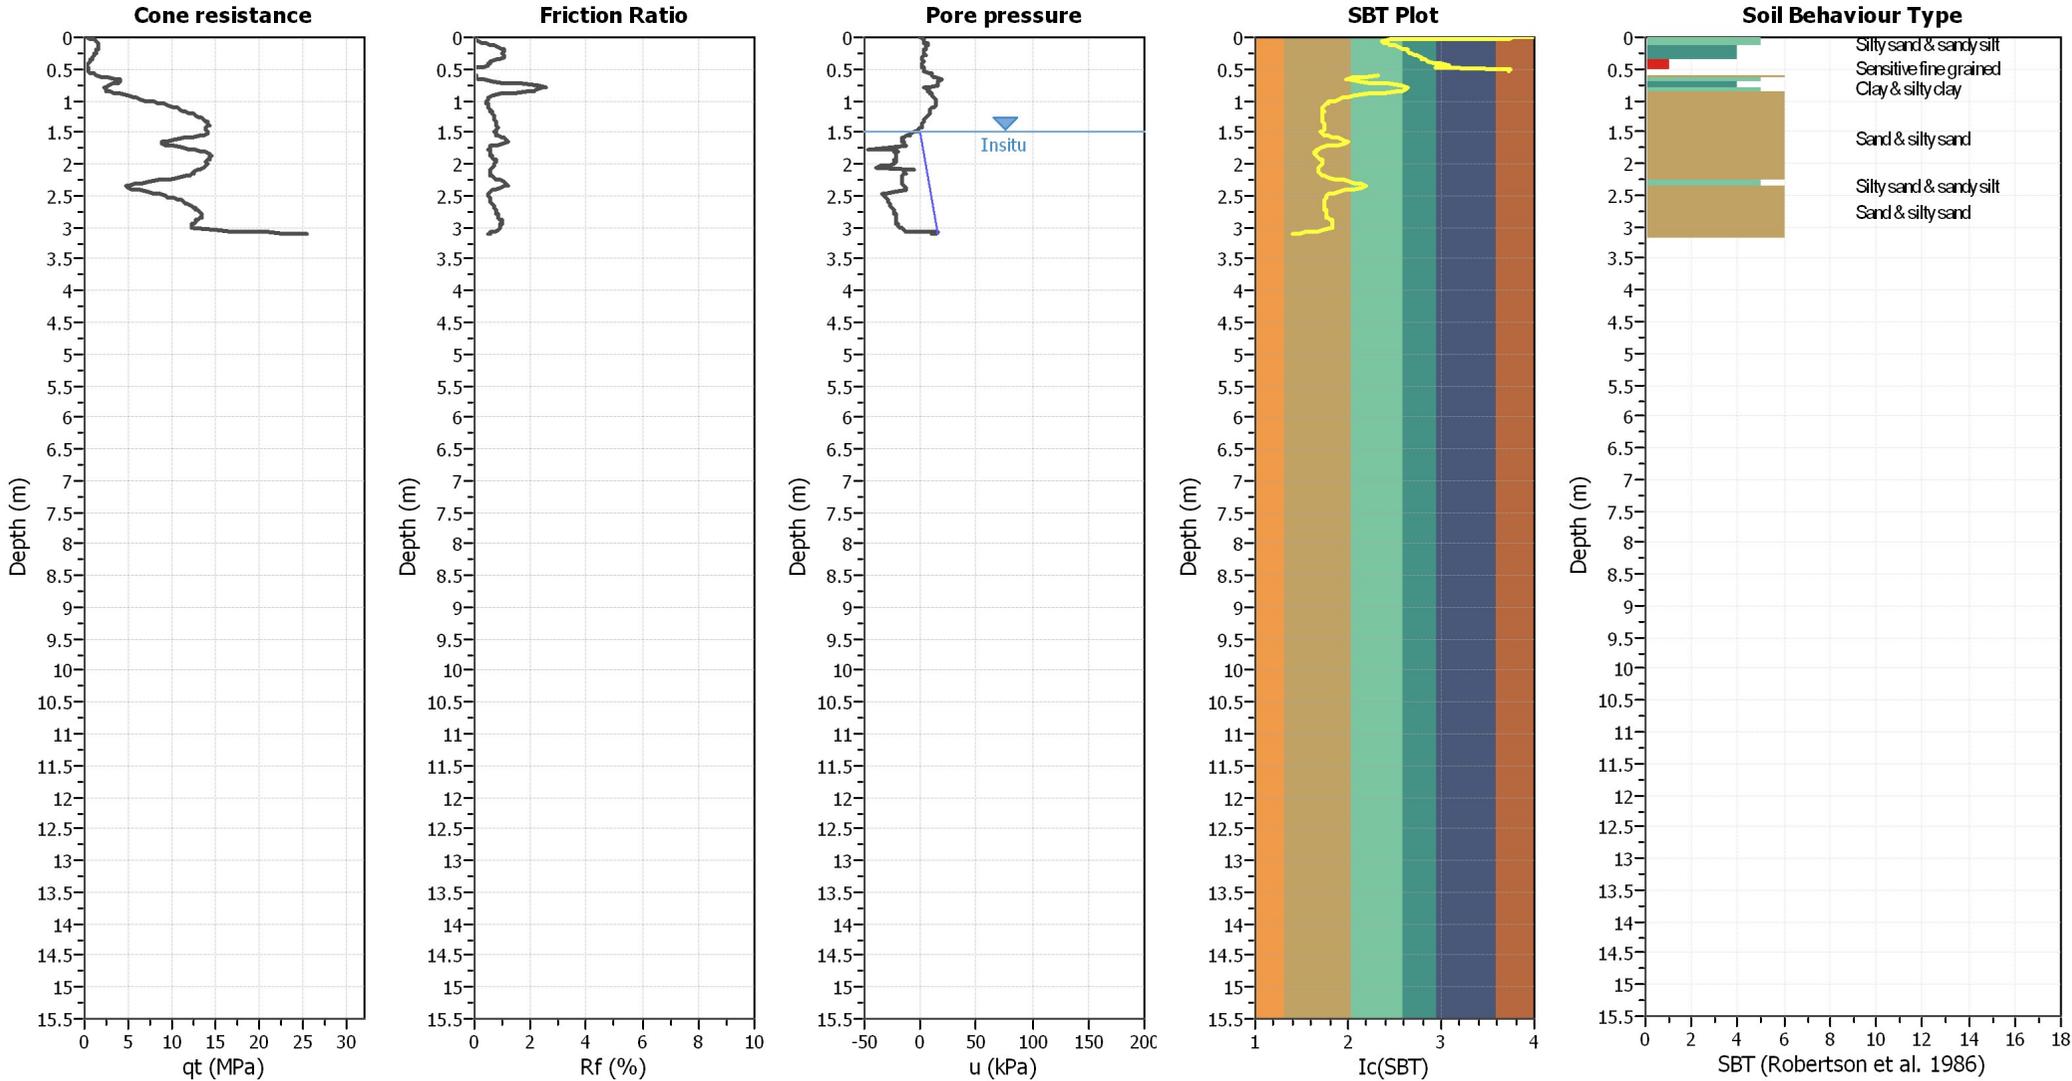
**CPT basic interpretation plots**

Analysis method:	I&B (2008)	Depth to GWT (erthq.):	1.00 m	Fill weight:	N/A
Fines correction method:	I&B (2008)	Average results interval:	3	Transition detect. applied:	Sands only
Points to test:	Based on Ic value	Ic cut-off value:	2.60	K <sub>σ</sub> applied:	Yes
Earthquake magnitude M <sub>w</sub> :	7.50	Unit weight calculation:	Based on SBT	Clay like behavior applied:	.
Peak ground acceleration:	0.35	Use fill:	No	Limit depth applied:	No
Depth to water table (insitu):	1.50 m	Fill height:	N/A	Limit depth:	N/A

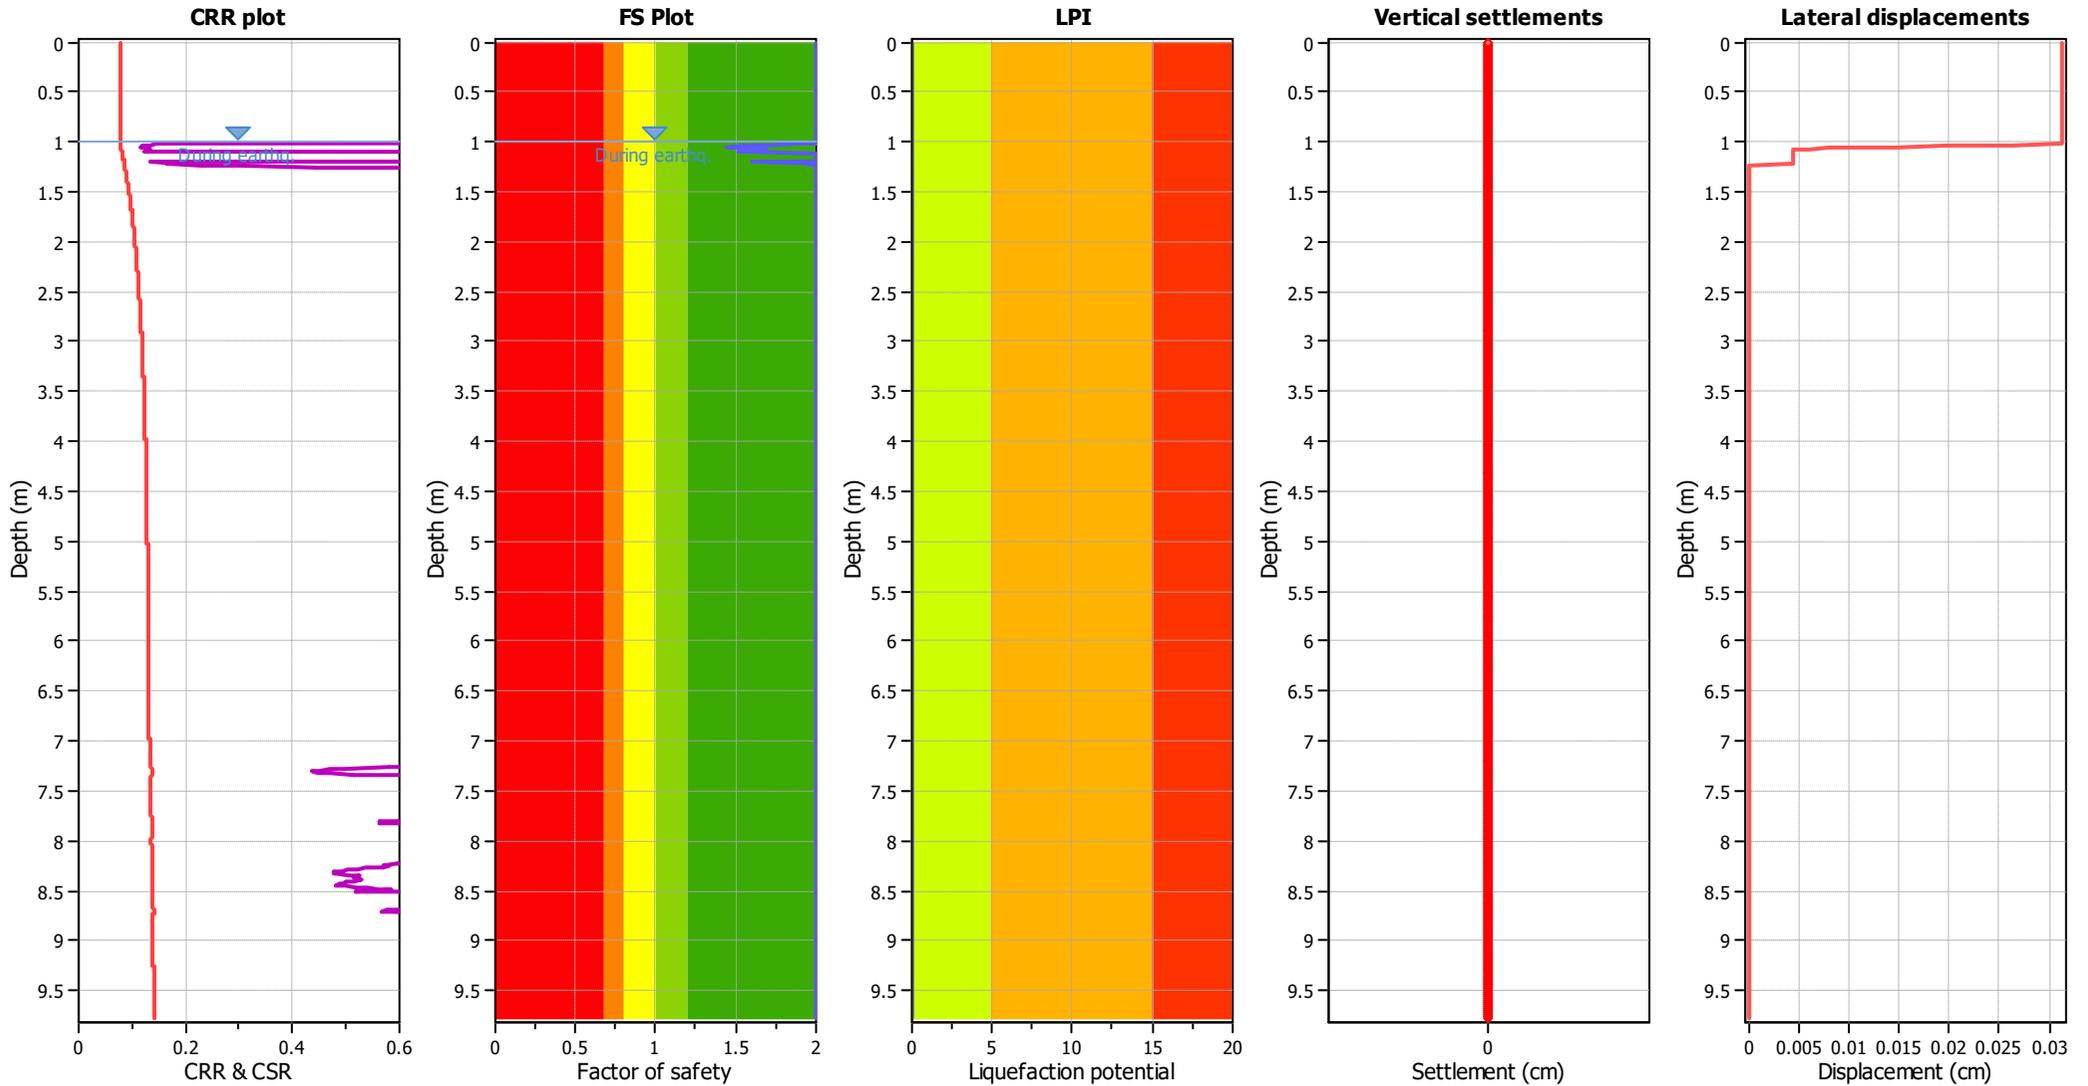
### Liquefaction analysis overall plots

Analysis method:	B&I (2014)	Depth to GWT (erthq.):	1.00 m	Fill weight:	N/A
Fines correction method:	B&I (2014)	Average results interval:	3	Transition detect. applied:	No
Points to test:	Based on Ic value	Ic cut-off value:	2.60	K <sub>σ</sub> applied:	Yes
Earthquake magnitude M <sub>w</sub> :	7.50	Unit weight calculation:	Based on SBT	Clay like behavior applied:	Sands only
Peak ground acceleration:	0.13	Use fill:	No	Limit depth applied:	No
Depth to water table (insitu):	1.00 m	Fill height:	N/A	Limit depth:	N/A

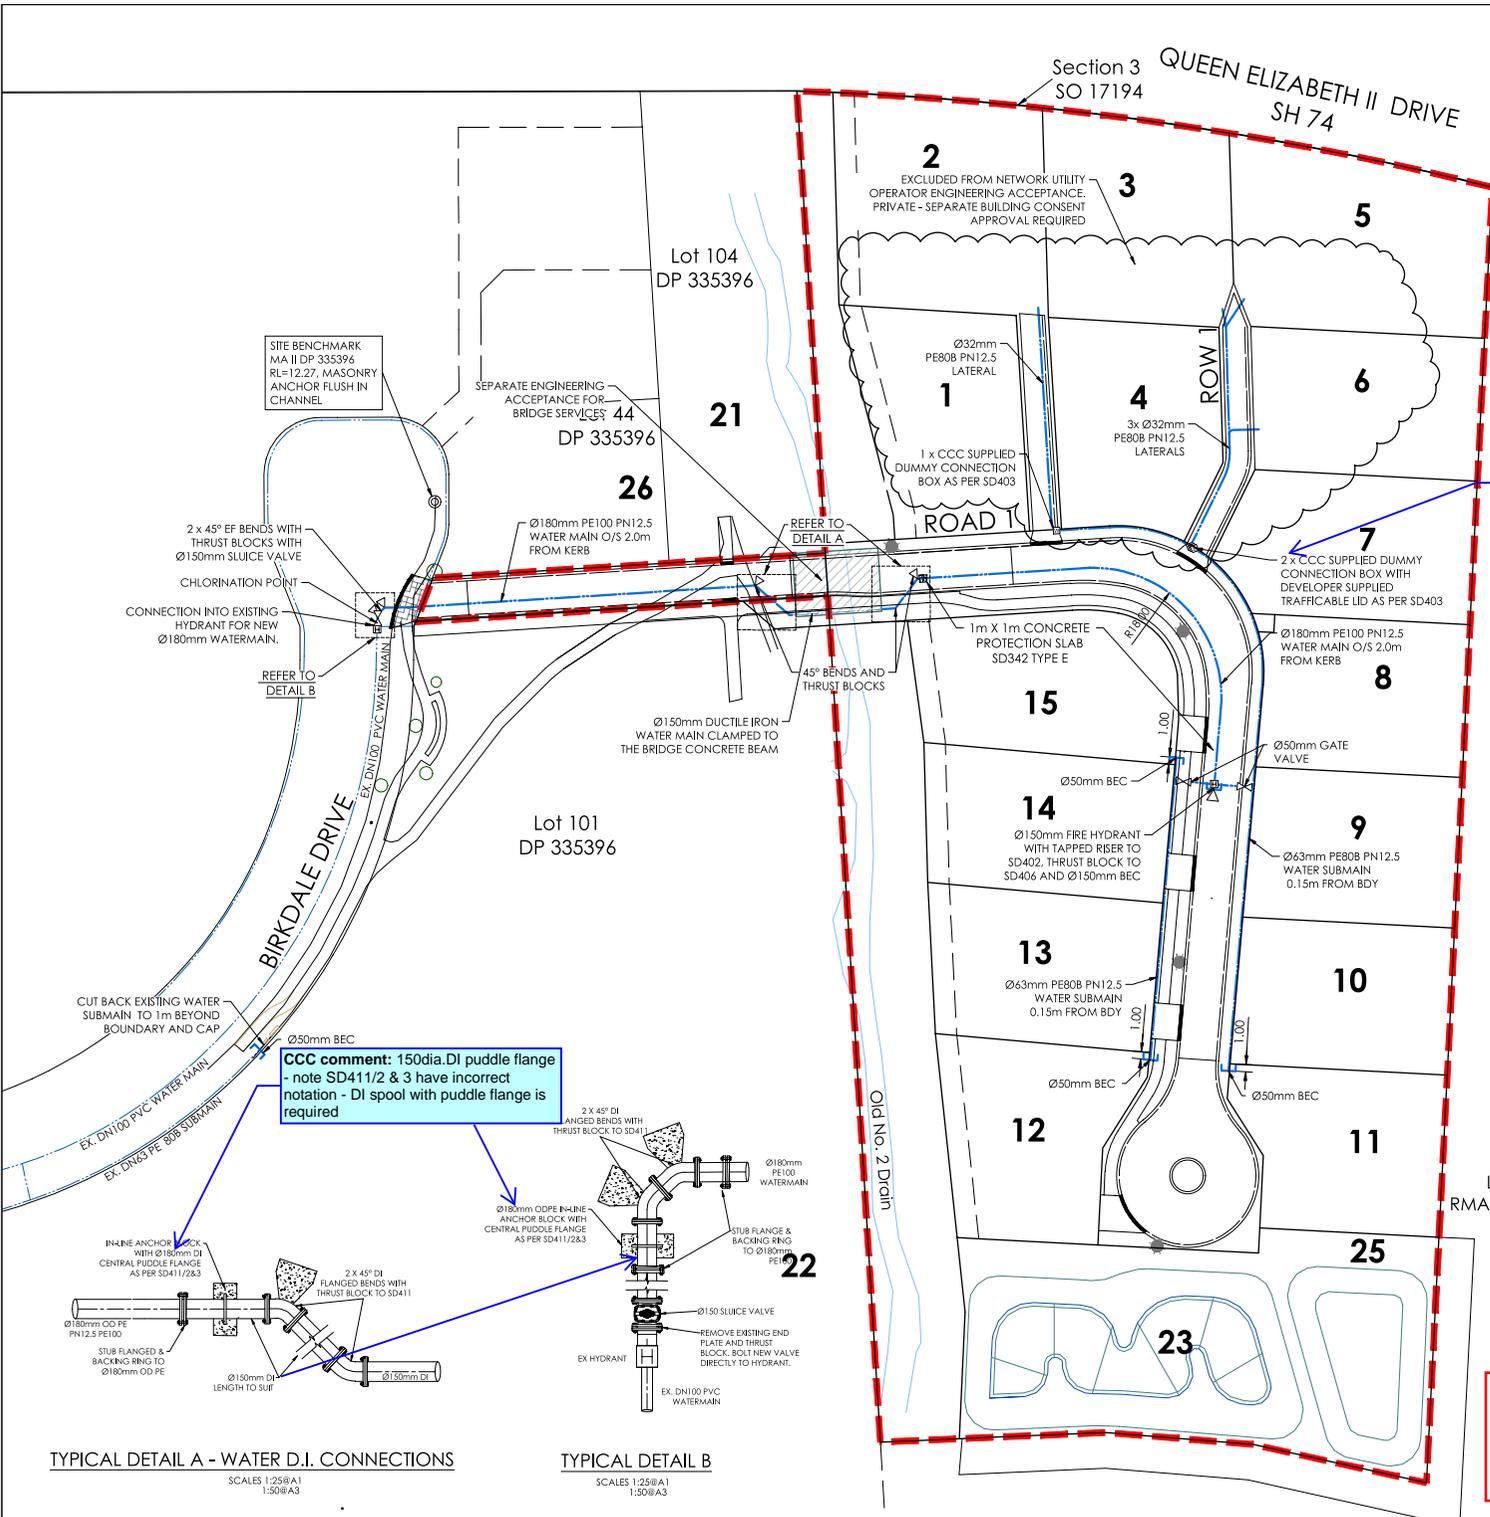
**CCC comment: 3 x CCC supplied dummy water connections installed in two Developer supplied trafficable connection boxes as per SD403**

**CCC comment: 150dia. DI puddle flange - note SD411/2 & 3 have incorrect notation - DI spool with puddle flange is required**

TYPICAL DETAIL A - WATER D.I. CONNECTIONS
