Geotechnical Investigation Report Stirling Park Subdivision, 734 Springs Road, Prebbleton, Selwyn District

Suburban Estates Ltd

Document Number: 18258-RPTGEO-001-A

Date: 2 August 2018

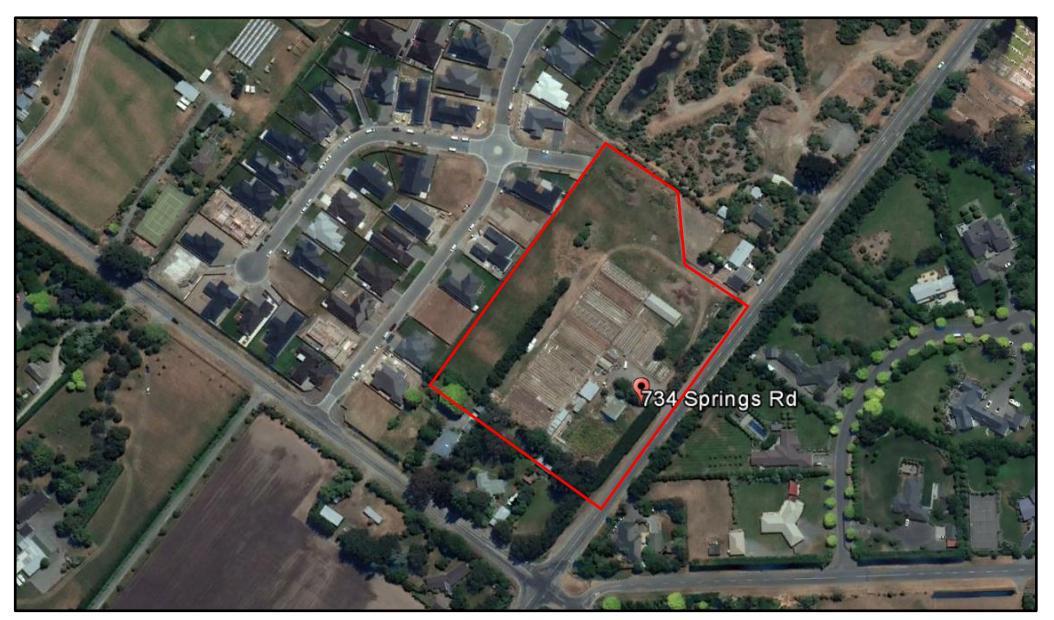
Figure 1: Site Location Plan

A site layout plan is presented in Figure 1.

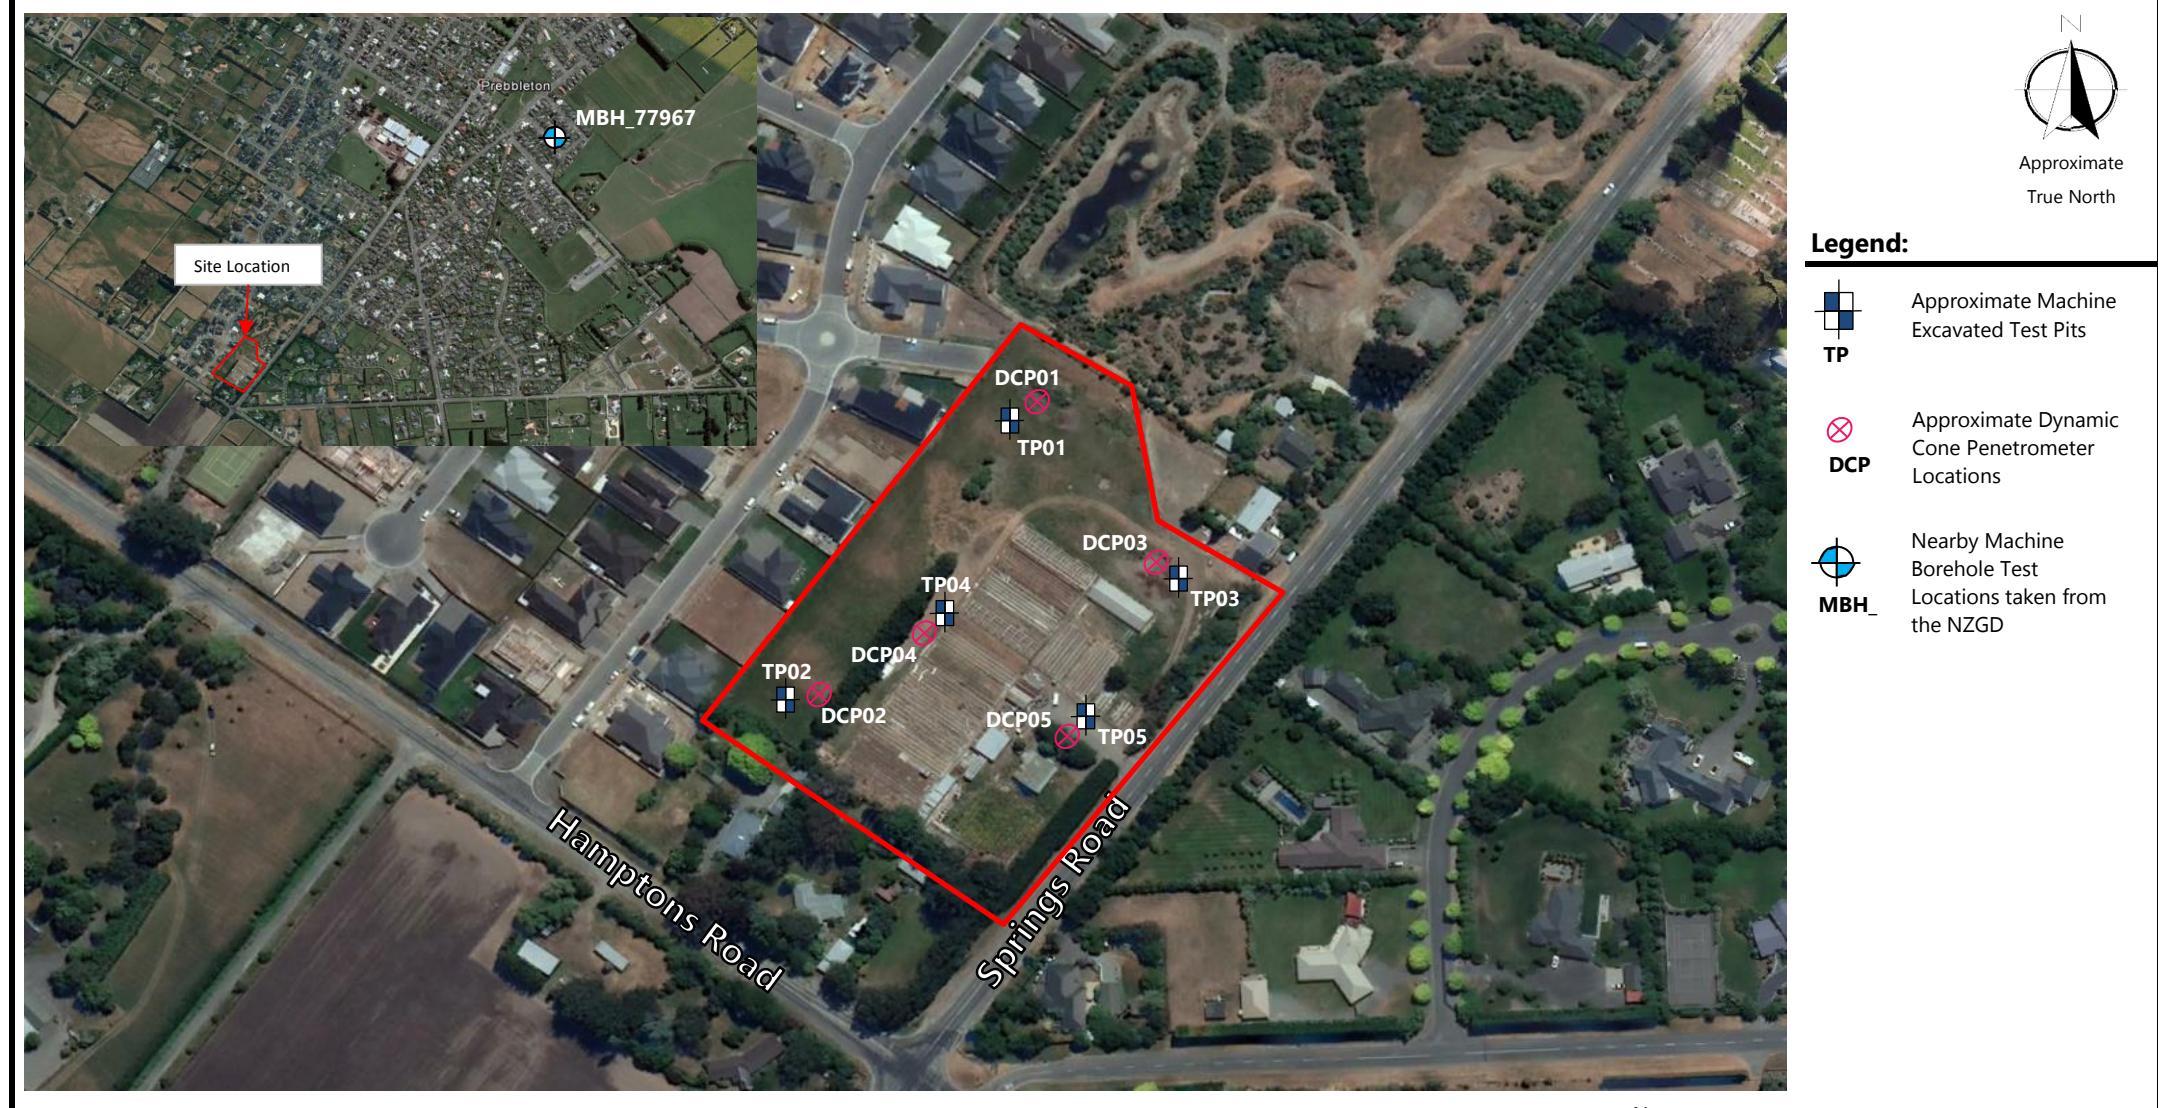
Appendix B Test Location Plan

CGW Consulting Engineers Test Location Plan adapted from Ecan or Google maps.
It should be borne in mind that locations of features are approximate only.
Original plan size A4.

Civil Structural Environmental	tructural Environmental DATE: July 2018 Test Location Plan		Test Location Plan	DRAWING NO:
	Geotechnical	DRAWN:	JF	Stirling Park Subdivision	10250/1
	Nelson Ph: 548 - 8259	SCALE:	NTS	734 Springs Road	16236/1
Consulting Engineers	Christchurch Ph: 348 - 1000	CAD REF:	18258	Prebbleton	SHEET 1 OF 1

All test locations are presented on drawing 18258/1 in Appendix B with Test Pit and Dynamic Cone Penetrometer results showing detailed soil descriptions and blows per 100 mm penetration presented in Appendix C.
