# GEOTECHNICAL INVESTIGATION AND FOUNDATION RECOMMENDATIONS: XXXX. **STAGE 1, OAKBRIDGE SUBDIVISION.**

Davis Ogilvie & Partners Ltd. (Davis Ogilvie) has been commissioned by Sovereign Palms Ltd to determine the ground bearing capacity and provide foundation recommendations for XXXX, Stage 1 of the Oakbridge Subdivision in Marshlands, Christchurch.

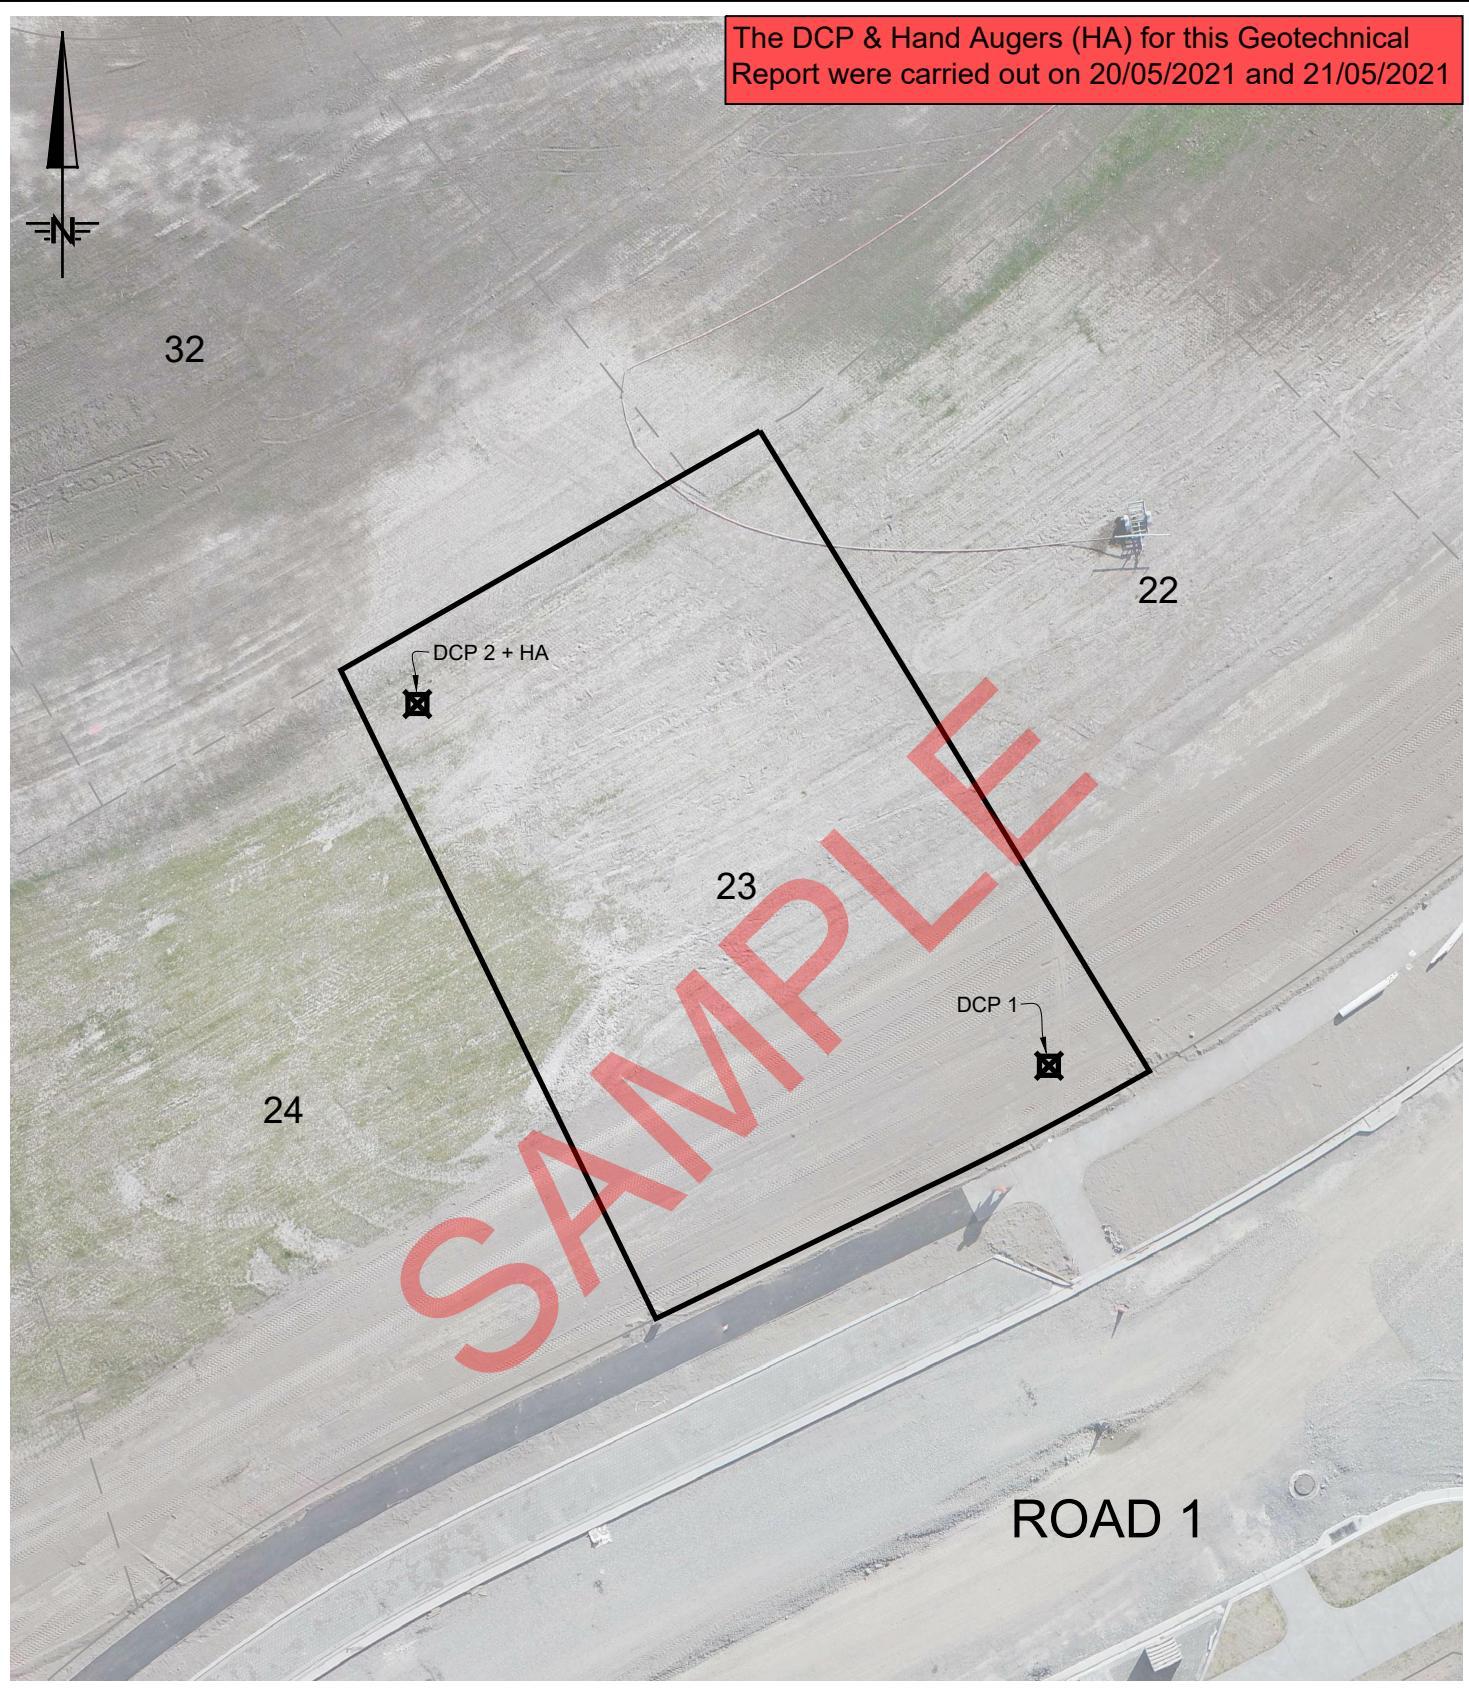
Geotechnical Site Plan	design MS	drawn IZ	QA check MS	dwg issue
XXXX, Stage 1 Oakbridge Subdivision	scale @ A4	date	file	G23 A
Oakbridge Suburvision	1:300	05/21	34300

Following fill placement, two DCPs and one hand auger (HA) was undertaken on the lot to a maximum depth of 3.0 m below the final ground level (FGL). These test locations are presented in the attached Geotechnical Site Plan G23A, and DCP and HA logs are enclosed.

Test locations are approximate. 0m 10m 15m 20m 25m 30m 2011 2011 Boundaries are taken from Davis Ogilvie Civil Design Drawing DWG C106. Scale 1:300 Aerial image obtained from drone by DO Survey 16/04/21
